# UNITED STATES COAST GUARD

## MARINE INVESTIGATIONS LESSONS LEARNED

Lessons Learned 01-09

### SMALL FIRE / IMPORTANT LESSONS

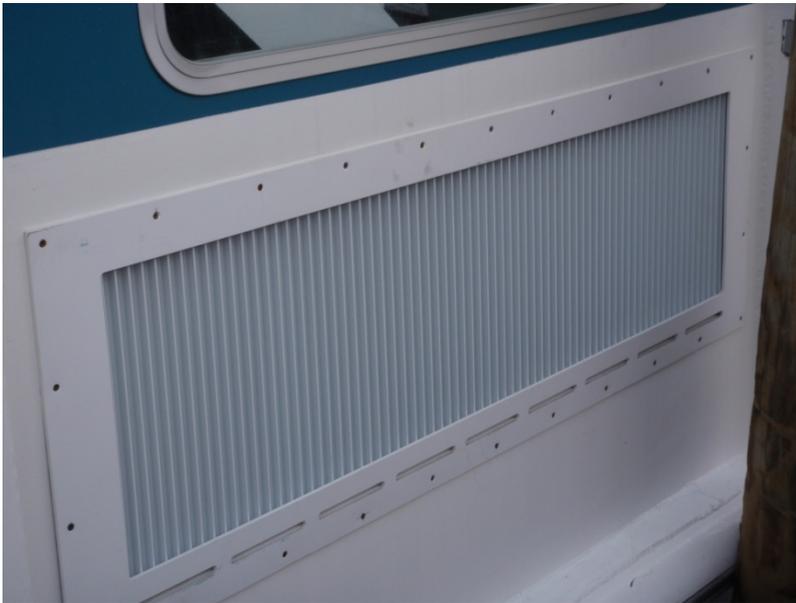
When the extinguishing system was activated, all the dampers closed properly. However, after the fire it was noted that several external moisture eliminator filters were extremely damaged. The photo above shows an undamaged moisture eliminating filter. The actual size of this filter is about five feet by fifteen inches.

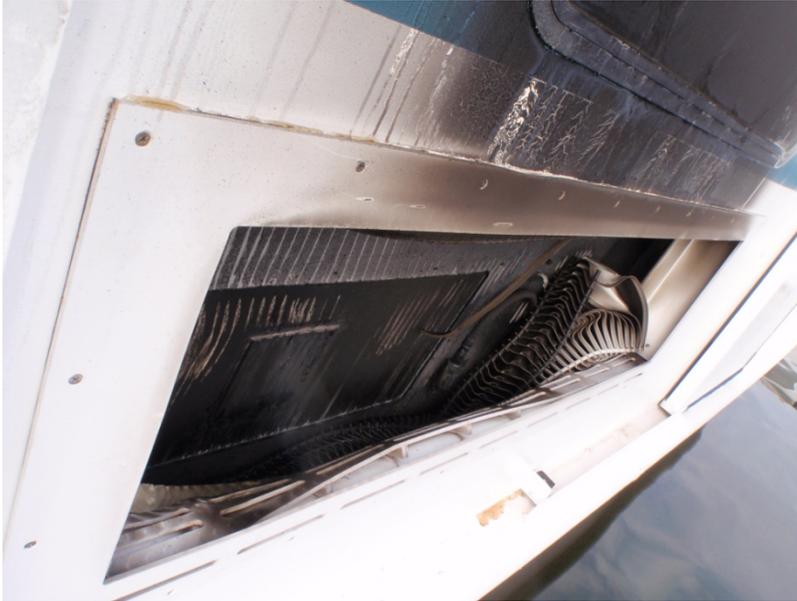
The following photo shows the melted moisture eliminating filter from the opposite side of the vessel. High temperature gases flowed through it during the fire causing it to overheat and deform prior to its respective damper closing. It fell on top of the damper after the damper had closed. The small fire in the engine room was about nineteen feet away on the other side of the vessel and aft. Investigators

noted that *if* the filter had melted and fallen on or into the slot of the duct before the damper closed, it is likely to have interfered with the damper operation and possibly have reduced the effectiveness of the CO2 system.

46 CFR 116.610 (b) applicable to this vessel, states that “a ventilation duct, and materials incidental to installation must be made of noncombustible material.” 46 CFR 116.610(c) states that “combustibles and other foreign materials are not allowed within ventilation ducts. However metal piping and electrical wiring installed in a metal protective enclosure may be installed within ventilation ducts, provided that the piping or wiring does not interfere with the operation of fire dampers.” Owners and operators of any type vessel, as well as those persons involved with the inspection of vessels should be aware of the potential risks associated with this and similar installations and are reminded that

inspections of fire dampers should include observation of all related structure near dampers to ensure that the dampers will operate under fire conditions. These structures and any incidental materials should not be made of combustible material. On vessels with manual extinguishing systems, or those with manual dampers whereby when securing the ventilation time is of the essence, consideration needs to be given regarding the materials used should it be subjected to excessive heat carried by high temperature gases.

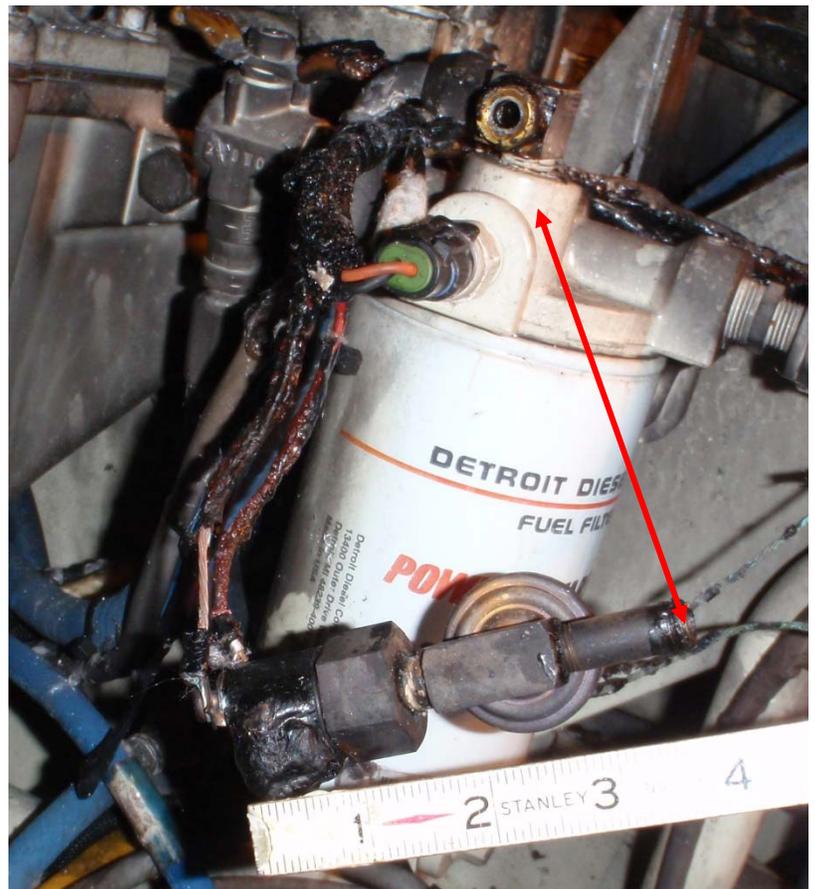
As stated previously, the investigation into this casualty is not yet complete. The components of the pipe fitting which failed are currently being examined by NTSB metallurgists. It is suspected however that the failed fittings may have been subjected to excessive vibration which could have caused the fracture. The original configuration was modified by adding a fitting that attached two additional sensors (for a total of four) to the fuel filter assembly and was subject to pressures up to 65 psig or greater. The assembly weighed 6.3 ounces and extended about 4 inches out of a reducing bushing that was threaded into the inlet fitting of the filter. Because of the location of the fire and oil soaked insulation it is

suspected that the fitting leaked first and did not immediately shear as shown in the photo at the right.

Owners and operators of any type vessel, as well as those persons involved with the inspection of vessels should be aware of the potential risks associated by adding components to an engine assembly and must take into account the effect of vibration on those components. If add-on components are discovered effort should be made to verify the adequacy and safety of the installation by consulting the engine manufacturers and designers.

In this instance an improved installation may have involved mounting the sensors directly to a stable surface and attaching the sensors to the filter inlet using a flexible hose.

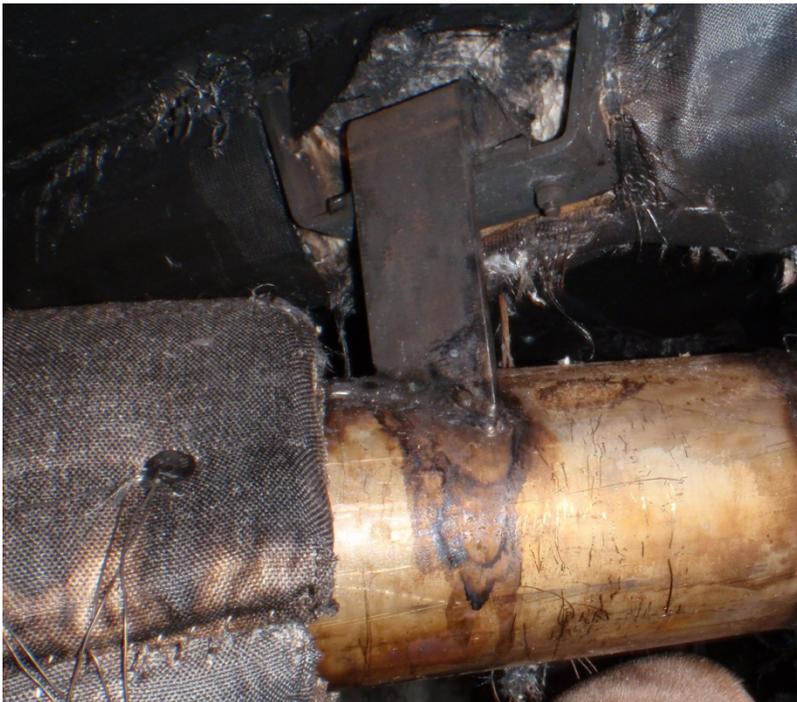
In a small engine room containing several engines and having a low overhead there are a number of locations that present enough heat to cause a fuel to flash and ignite other components. Turbocharger and exhaust piping insulation while serving to reduce heating of external areas also helps reduce the immediate availability of ignition hot spots. Care should be taken to ensure insulation wraps and blankets are kept tight and fastened in a manner to prevent dripping or spraying fluids from traveling to an exposed hot spot. Insulation seams should be made tight and where possible aligned in a manner to prevent pooling of fluid and to repel dripping. Likewise good marine practice may also dictate and ensure that braces which are welded directly to the exhaust pipe which serve as hangers or supports

also be insulated. Heat conducting from the exhaust pipe to the brace could be substantial allowing the exposed bracket to become nearly as hot as the exhaust pipe. The brace in the photo above was only partially covered with the insulation that was wrapped around the exhaust pipe. As with the other concerns in this document, owners and operators of any type vessel, as well as those persons involved with the inspection of vessels should be aware of the potential risks associated with improper or inadequate installation of insulation.
